## **Corrosion Resistant Polyurea Coating for Concrete Water Tank**

Project: Sandblasting and corrosion resistant polyurea coating of concrete ceiling in water tank

Location: Waukegan, IL

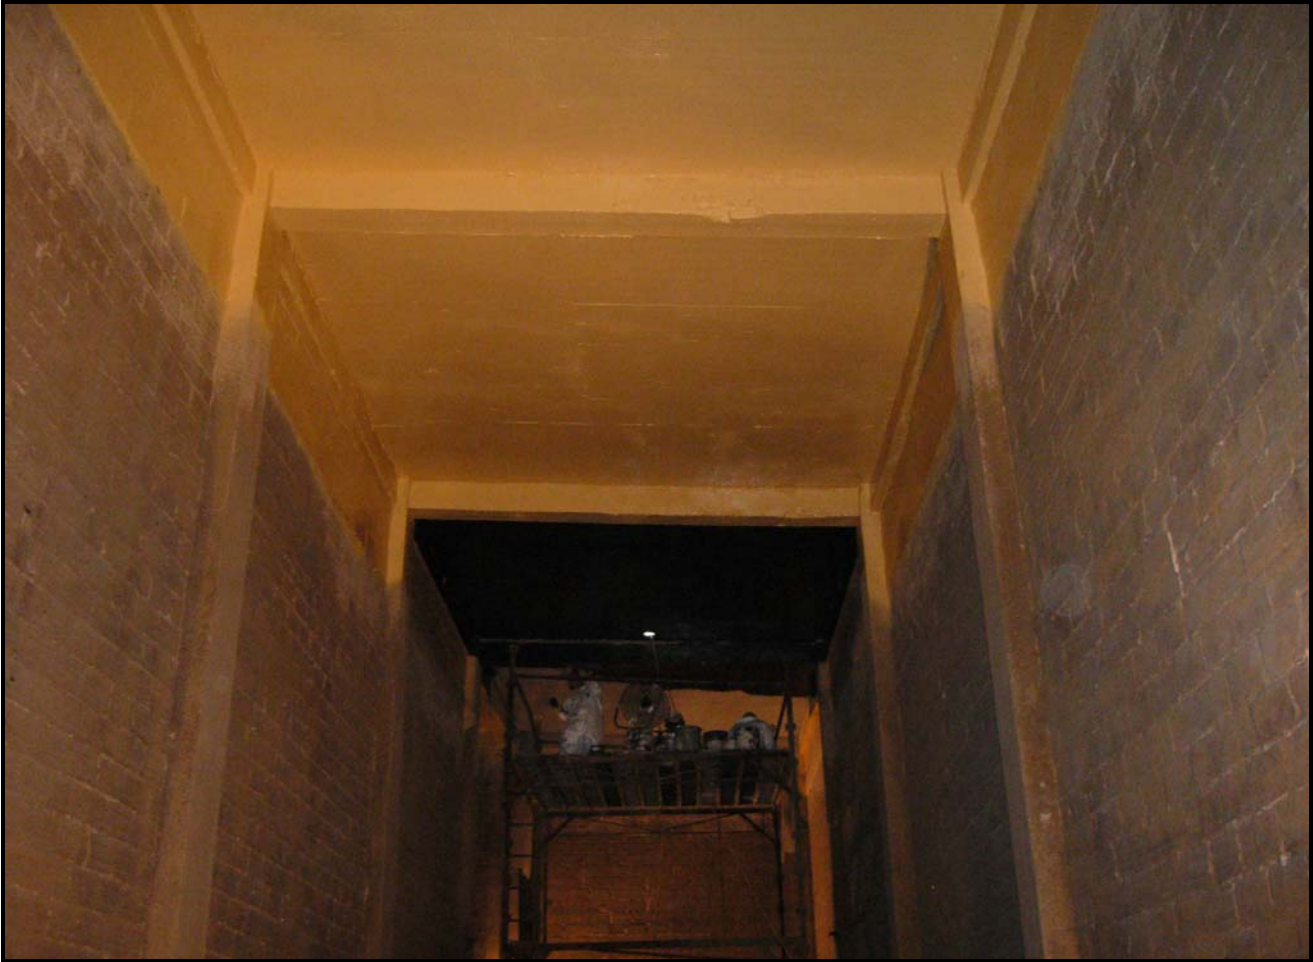
Scope: Entire ceiling and 2' down around entire perimeter of tank

Steel: Blasted to SSPC SP-7 sweep blast

Primer: Graphite filled epoxy conductive primer (for running spark test)

Coating: 30-40 mils dry film thickness of corrosion resistant polyurea coating
